Machinery Messages

Case History

Identification of a unique vibration problem

Alabama Power Corporation's Barry Steam Plant, located in Bucks, Alabama, operates a coal-fired, Westinghouse 270 MW cross compound steam turbine generator. This unit is composed of two separate machine trains - a high pressure (HP) train and

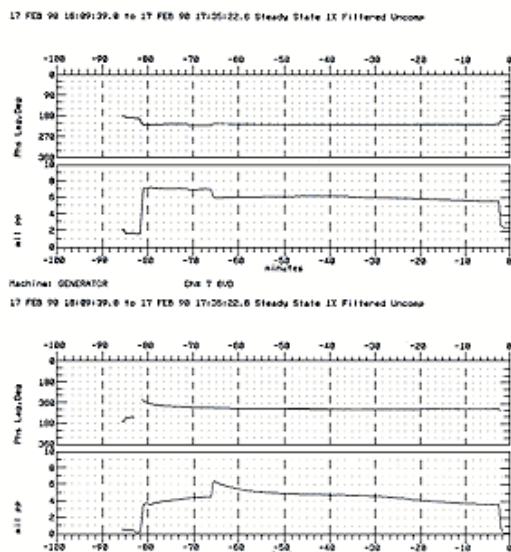
Figure 2

Data showing increasing step change in vibration amplitude at bearing #5 and #6.

The first tapes that arrived at Bently Nevada on 18 February 1990 showed a rather severe 6 mils (152 μ m) pp increasing step change in the vibration amplitude on the vertical transducers at bearings #5 and #6 as shown in Figure 2. The horizontal transducer at bearing #5 indicated a somewhat lower 3.5 mils (89 μ m) pp change, while the horizontal readings at bearing #6 were still lower at 2 mils (51 μ m) pp. Bearings #3 and #4 had not exceeded 2 mils pp (51 μ m) in amplitude change.

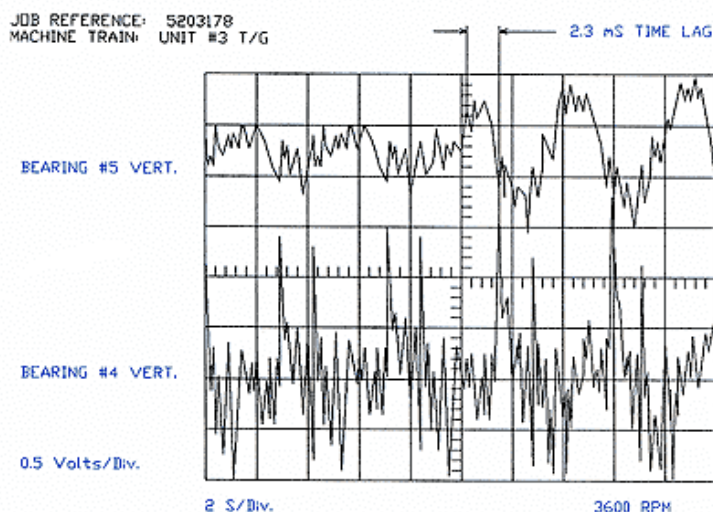
Figure 4, the direct timebase trace of bearings #4 and #5 vertical transducers during a vibration step change, shows a 1-3 millisecond lead in the signal change at bearing #5, indicating the source of the problem to be in the generator as ►

Figure 4
Direct timebase of bearings #4 and #5 vertical transducers.

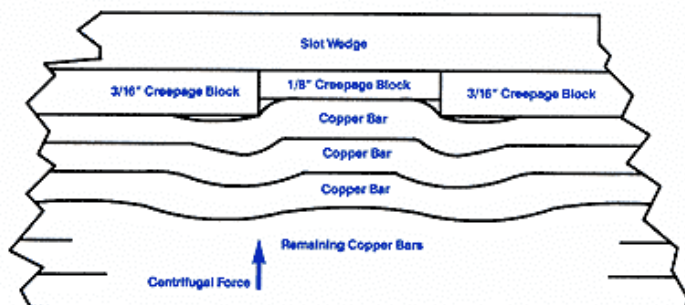
Figure 5
(Exaggerated) example of copper bar deformation due to centrifugal force and non-uniform blocking.

In September 1990, the plant took the unit off line for an inspection and overhaul. The generator rotor was returned to the repair shop that did the original rewinding and carefully disassembled. As suspected, it was found that the G-11 type insulation (creepage blocking) beneath the slot wedges had been improperly sized. Varying sizes of blocking had been installed during reinstallation of the slot wedges.

Figure 5 illustrates, in an exaggerated form, how the copper bars deformed because of centrifugal force and non-uniform blocking, preventing them from expanding axially. The final repair resolution involved slightly milling the underside of the slot wedges in order to use a uniform strip of creepage block. This created a smooth slip plane between the copper and the blocking insulation, allowing uniform axial expansion of the copper bars.
